Huddlestone-Berry
Engineering & Testing, LLC

September 29, 2015
Project#01302-0002

Subject: Engineering Evaluation
Upper Gladstone Ponds
Gold King Mine

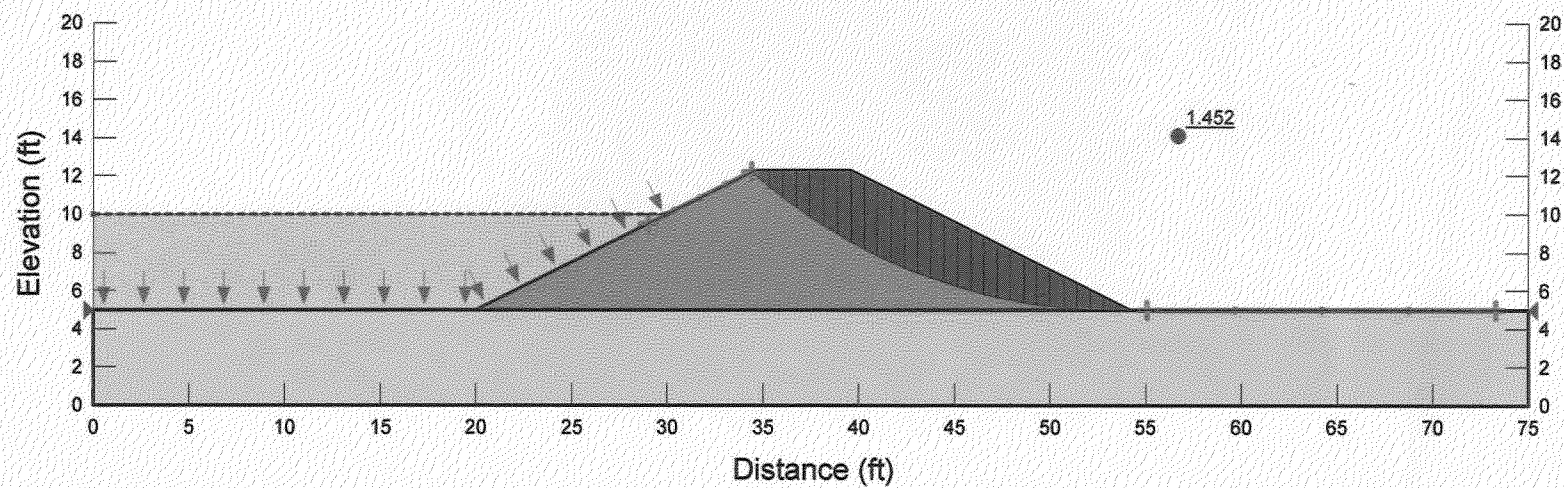
Upper Gladstone Ponds Critical Section

Analysis of the embankment was completed using the SLOPE/W computer software program. The Morgenstern-Price methodology was utilized in the analysis.

The results of the analysis yielded a Factor-of-Safety (FS) of 1.452. This is less than the FS of 1.5 typically required for long-term stability.

Information regarding the berm construction was provided to HBET by Weston Solutions, Inc. (Weston). A drawing titled *Upper Gladstone Ponds* prepared by Weston and dated September 25, 2015 suggests that the maximum berm height is approximately 7.3 feet based upon the spot elevations on the drawing. The following additional information was provided by Weston:

- The berm was constructed of non-plastic sandy gravel soils
- The berm was constructed using approximately 1 foot lifts
- The berm was compacted with the excavator bucket
- The berm material was dry
- The maximum height of water in the ponds is 5 feet
- The berm side slopes are approximately 2H:1V
- The top of the berm is approximately 5 feet wide
- The subgrade below the berm is fairly level

- $\gamma = 120$ pcf
- $\phi' = 28^\circ$

- $\gamma = 120$ pcf
- $\phi' = 26^\circ$
